**Flood Control Project Maintenance
Levee Inspections**

Maintenance Issue Types Only, Levee Inspection Report By Mile - Fall 2018

Sacramento Maintenance Yard Cache Creek

Waterway	Bank	Unit Miles	Inspection Start/End	Inspector
Unit No. 01 North Levee	Left	11.69	09/04/2018 09/20/2018	Zach Jojola

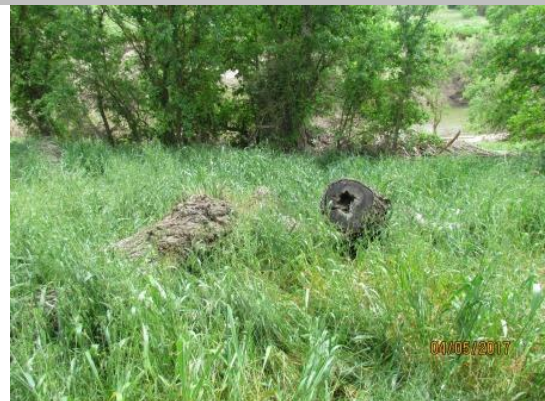
Photo 1 of 1 : FA_2018_ST0001_259_81_20180904_00049.jpg

LM Start	2.20	Rating **	M	Issue No.	81
LM End	2.20	Issue Type +	Ma	Location *	WS
Category	Earthen Levee			GPS Latitude/Longitude	
				Start	End
Item	Encroachments			38.733688 °	38.733688 °
				-121.804215 °	-121.804215 °
DWR ID	DWR_ST0001_01_s_2017_81				
Comment Code					
TR : Tree or limb					
Inspector Comment					
Dead tree stumps on waterside levee slope.

Dead tree stumps on waterside levee slope. Spring 2017.

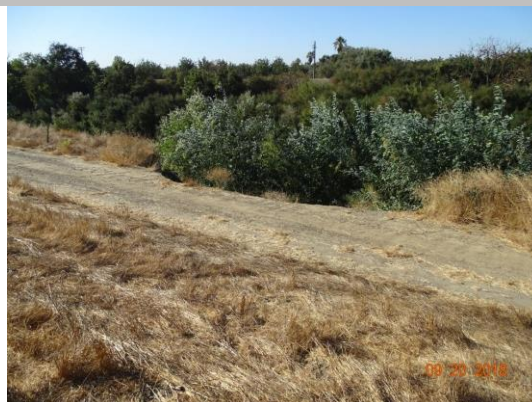
Photo 1 of 3 : FA_2018_ST0001_259_30_20180924_00072.jpg

LM Start	2.57	Rating **	A/W	Issue No.	30
LM End	2.61	Issue Type +	Ma	Location *	WS
Category	Supplemental			GPS Latitude/Longitude	
				Start	End
Item	2017 USACE Erosion Survey, DRAFT			38.732836°	38.732685°
				-121.797893°	-121.797154°
DWR ID	DWR_ST0001_01_f_2018_30				
Comment Code					
Inspector Comment					
2017 Site ID: CHC 2.4 L Status: Critical 2017 Field Notes: No observed change. Site History: Site identified as CRITICAL in 2002. 2006 - Currently constructing a setback levee. New failures present and extensive. Downstream end of the setback levee did not extend far enough. Upstream end was repaired. 2007 - DWR repaired with a setback levee, but the levee did not go far enough downstream. 2012 - New cracks observed. 2013 - Fresh erosion on upper bank.					
DWR Inspector Comment: No observed changes in erosion. Fall 2018.

View of erosion on the waterside toe road. Fall 2018.

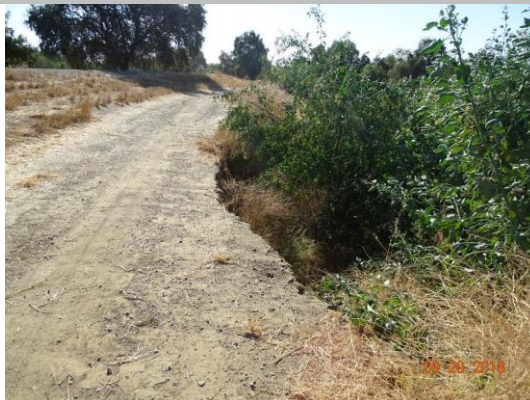
Photo 2 of 3 : FA_2018_ST0001_259_30_20180924_00073.jpg

2017 Site ID: CHC 2.4 L
Status: Critical
2017 Field Notes: No observed change.
Site History: Site identified as CRITICAL in 2002. 2006 - Currently constructing a setback levee. New failures present and extensive. Downstream end of the setback levee did not extend far enough. Upstream end was repaired. 2007 - DWR repaired with a setback levee, but the levee did not go far enough downstream. 2012 - New cracks observed. 2013 - Fresh erosion on upper bank.

DWR Inspector Comment: No observed changes in erosion. Fall 2018.

Additional view of the erosion, facing downstream. Fall 2018.

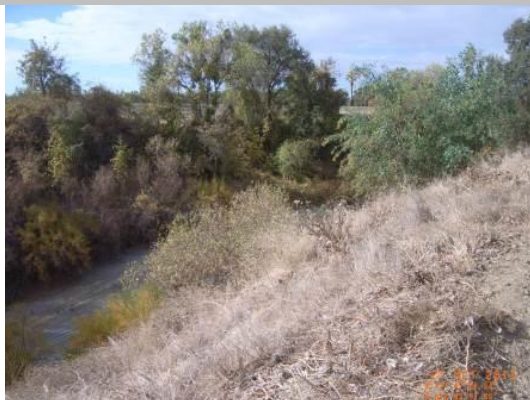
Photo 3 of 3 : FA_2018_ST0001_259_30_20181023_00033.jpg

USACE 2013 Photo #1

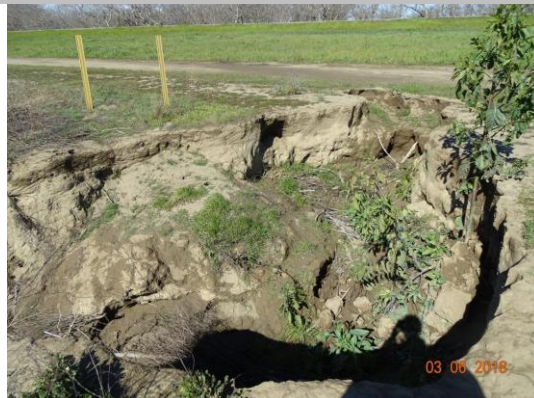
Photo 4 of 5 : FA_2018_ST0001_259_62_20180904_00042.jpg

LM Start	2.84	Rating **	A/W	Issue No.	62 (cont)	
LM End	2.84	Issue Type +	Ma	Location *	WS	
Category	Earthen Levee			GPS Latitude/Longitude		
				Start		End
Item	Erosion / Bank Caving			38.734514 °	38.734514 °	
				-121.793418 °	-121.793418 °	
DWR ID	DWR_ST0001_01_s_2018_62					
Comment Code						
E1 : Note and monitor erosion site.						
Inspector Comment						
Erosion on waterside berm and toe road.

Additional view of erosion, looking northwest. Spring 2018.

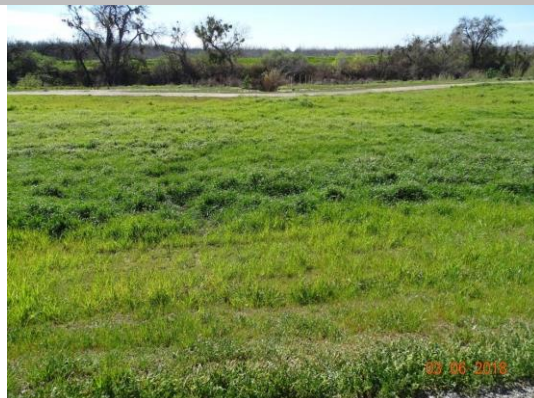
Photo 5 of 5 : FA_2018_ST0001_259_62_20180904_00043.jpg

View of erosion from levee crown, facing Cache Creek. Fall 2018.

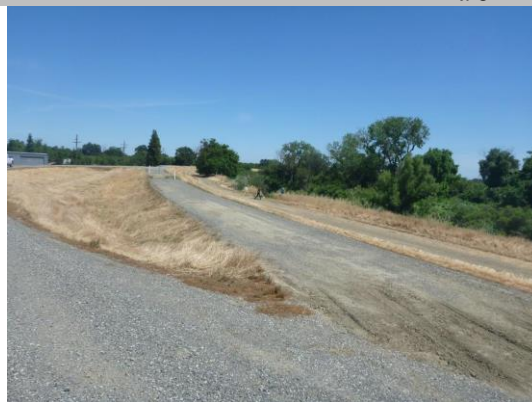
Photo 1 of 3 : LEVAL_FA_2018_249_954.jpg

LM Start	4.22	Rating **	A/W	Issue No.	34
LM End	4.23	Issue Type +	Ma	Location *	WS
Category	Supplemental			GPS Latitude/Longitude	
				Start	End
Item	2017 Storm Damage			38.727207 °	38.727187 °
				-121.775521 °	-121.775450 °
DWR ID	DWR_ST0001_01_f _ 2017_34				
Comment Code					
Inspector Comment					
Levee Evaluation Comments					
Description:					
Site ID No:249					
Site Designation:LMA-57					
Repair Type: Erosion					
Rating:Area of Concern					
Field Date:6/2/2017					
Notes: setback levee site; remaining berm greater than 86 feet, no section taken, photo only.

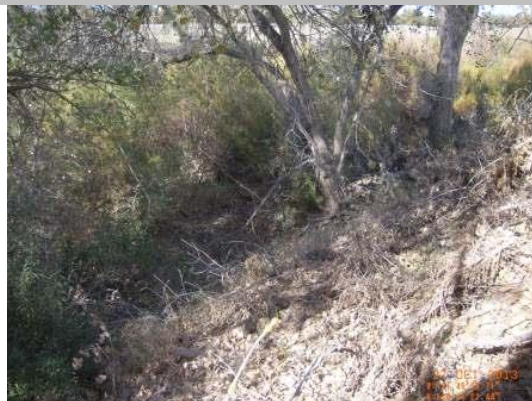
Photo 1 of 1 : FA_2018_ST0001_260_2_20181023_00001.jpg

LM Start	3.53	Rating **	A/W	Issue No.	2
LM End	3.60	Issue Type +	Ma	Location *	WS
Category	Supplemental			GPS Latitude/Longitude	
				Start	End
Item	2017 USACE Erosion Survey, DRAFT			38.722138°	38.723294°
				-121.759736°	-121.759588°
DWR ID	DWR_ST0001_02_f_2018_2				
Comment Code					
Inspector Comment					
2017 Site ID: CHC 3.5 R					
Status: Eroding					
2017 Field Notes: Significant amount of debris along bank.					
Site History: 2010 - Large slump on the upper berm, a tree has recently slid down the slope. 2011 - Large slump and new erosion. 2012 - Slightly steeper slopes and cracks observed.

USACE 2013 Photo #1

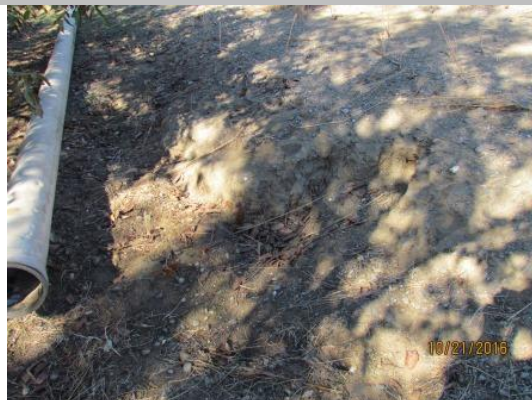
Photo 1 of 1 : FA_2018_ST0001_260_4_20180904_00004.jpg

LM Start	4.42	Rating **	A/W	Issue No.	4
LM End	4.42	Issue Type +	Ma	Location *	LS
Category	Earthen Levee			GPS Latitude/Longitude	
				Start	End
Item	Erosion / Bank Caving			38.726840 °	38.726840 °
				-121.747228 °	-121.747228 °
DWR ID	DWR_ST0001_02_f_2016_4				
Comment Code					
E1 : Note and monitor erosion site.					
Inspector Comment					
Erosion on LS slope near levee toe. It does not appear to pose a significant threat. Recommend monitoring.

Erosion on LS levee slope toward the toe. Fall 2016.

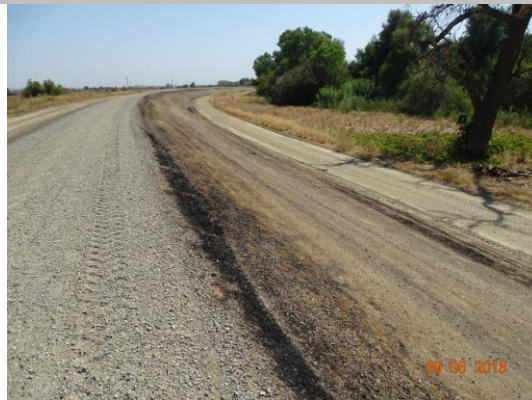
Photo 1 of 1 : FA_2018_ST0001_261_2_20180905_00008.jpg

LM Start	0.09	Rating **	A	Issue No.	2
LM End	0.09	Issue Type +	Ma	Location *	WS
Category	Earthen Levee			GPS Latitude/Longitude	
				Start	End
Item	Vegetation			38.726454 °	38.726454 °
				-121.717031 °	-121.717031 °
DWR ID	DWR_ST0001_04_f_2018_2				
Comment Code					
V1 : Control annual grass and weeds on the levee slopes and easements.					
Inspector Comment					
The Sacramento Maintenance Yard continues to manage the vegetation at an exceptional level.

View of the recently burned and dragged landside slope. Fall 2018.

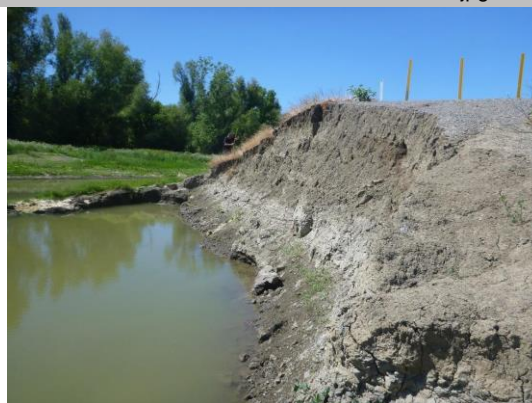
Photo 1 of 3 : LEVAL_FA_2018_250_962.jpg

LM Start	2.26	Rating **	M	Issue No.	1	
LM End	2.26	Issue Type +	Ma	Location *		
Category	Supplemental			GPS Latitude/Longitude		
				Start		End
Item	2017 Storm Damage			38.695424 °		38.695253 °
				-121.715914 °		-121.715926 °
DWR ID	DWR_ST0001_04_f_2017_1					
Comment Code						
Inspector Comment						
Levee Evaluation Comments						
Description:						
Site ID No:250						
Site Designation:LMA-58						
Repair Type: Erosion						
Rating:Area of Concern						
Field Date:6/2/2017						
Notes: training levee end slope where it keys into channel /access ramp erosion. No change as of fall 2018 inspection.

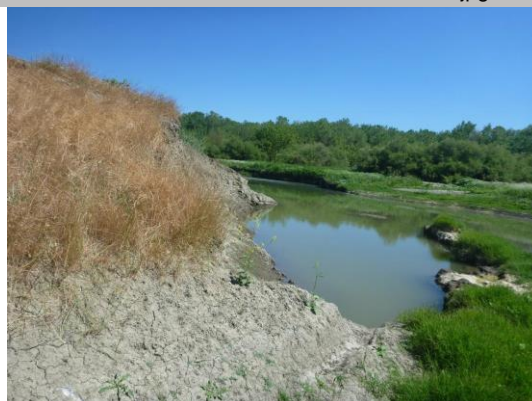
Photo 2 of 3 : LEVAL_FA_2018_250_964.jpg

LM Start	2.26	Rating **	M	Issue No.	1 (cont)	
LM End	2.26	Issue Type +	Ma	Location *		
Category	Supplemental			GPS Latitude/Longitude		
				Start		End
Item	2017 Storm Damage			38.695424 °		38.695253 °
				-121.715914 °		-121.715926 °
DWR ID	DWR_ST0001_04_f_2017_1					
Comment Code						
Inspector Comment						
Levee Evaluation Comments						
Description:						
Site ID No:250						
Site Designation:LMA-58						
Repair Type: Erosion						
Rating:Area of Concern						
Field Date:6/2/2017						
Notes: training levee end slope where it keys into channel /access ramp erosion. No change as of fall 2018 inspection.

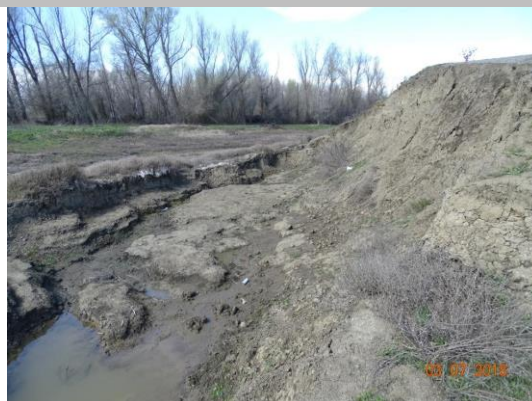
Photo 1 of 4 : FA_2018_ST0001_261_3_20180904_00004.jpg

LM Start	2.26	Rating **	A/W	Issue No.	3
LM End	2.26	Issue Type +	Ma	Location *	WS
Category	Earthen Levee			GPS Latitude/Longitude	
				Start	End
Item	Erosion / Bank Caving			38.695416 °	38.695416 °
				-121.715943 °	-121.715943 °
DWR ID	DWR_ST0001_04_s_2017_3				
Comment Code					
E2 : Schedule repair of erosion site prior to the next inspection.					
Inspector Comment					
Scour on waterside levee slope at end of Unit 04 levee. There is no visible active erosion at this time, however future high water events will likely cause further erosion into the levee prism.

View of scour on waterside levee slope at the end of Unit 4. Spring 2018.

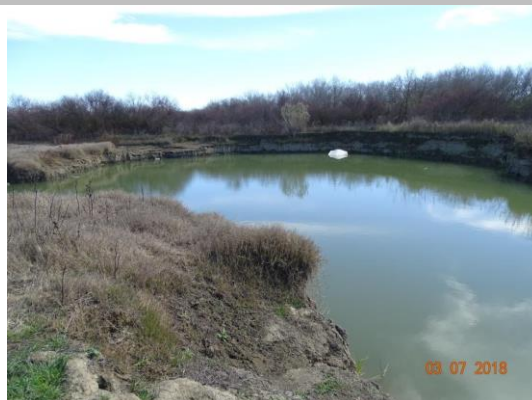
Photo 2 of 4 : FA_2018_ST0001_261_3_20180904_00005.jpg

View of newly scoured pond adjacent to the levee. Spring 2018.

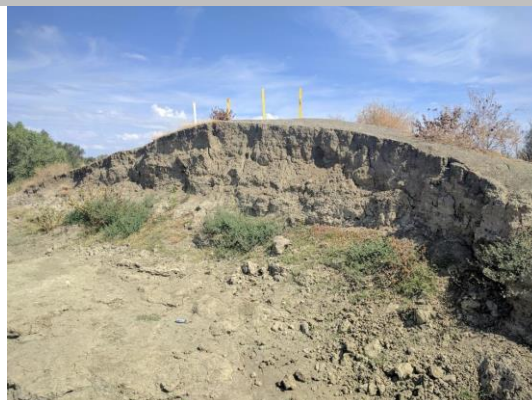
Photo 3 of 4 : FA_2018_ST0001_261_3_20180904_00006.jpg

View of scour at the end of the Training Levee. Ramp is inaccessible at this time. Fall 2017.

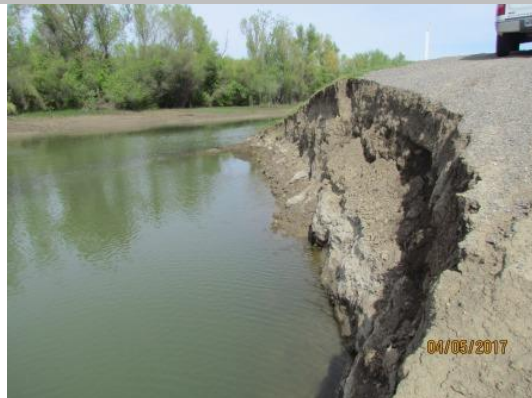
Photo 4 of 4 : FA_2018_ST0001_261_3_20180904_00007.jpg

LM Start	2.26	Rating **	A/W	Issue No.	3 (cont)	
LM End	2.26	Issue Type +	Ma	Location *	WS	
Category	Earthen Levee			GPS Latitude/Longitude		
				Start		End
Item	Erosion / Bank Caving			38.695416 °	38.695416 °	
				-121.715943 °	-121.715943 °	
DWR ID	DWR_ST0001_04_s_2017_3					
Comment Code						
E2 : Schedule repair of erosion site prior to the next inspection.						
Inspector Comment						
Scour on waterside levee slope at end of Unit 04 levee. There is no visible active erosion at this time, however future high water events will likely cause further erosion into the levee prism.

Scour on waterside levee slope at end of Unit 04 levee. Spring 2017.
